SESSION 3

Inspection and Maintenance of Dams and Spillways

Inspection of a dam

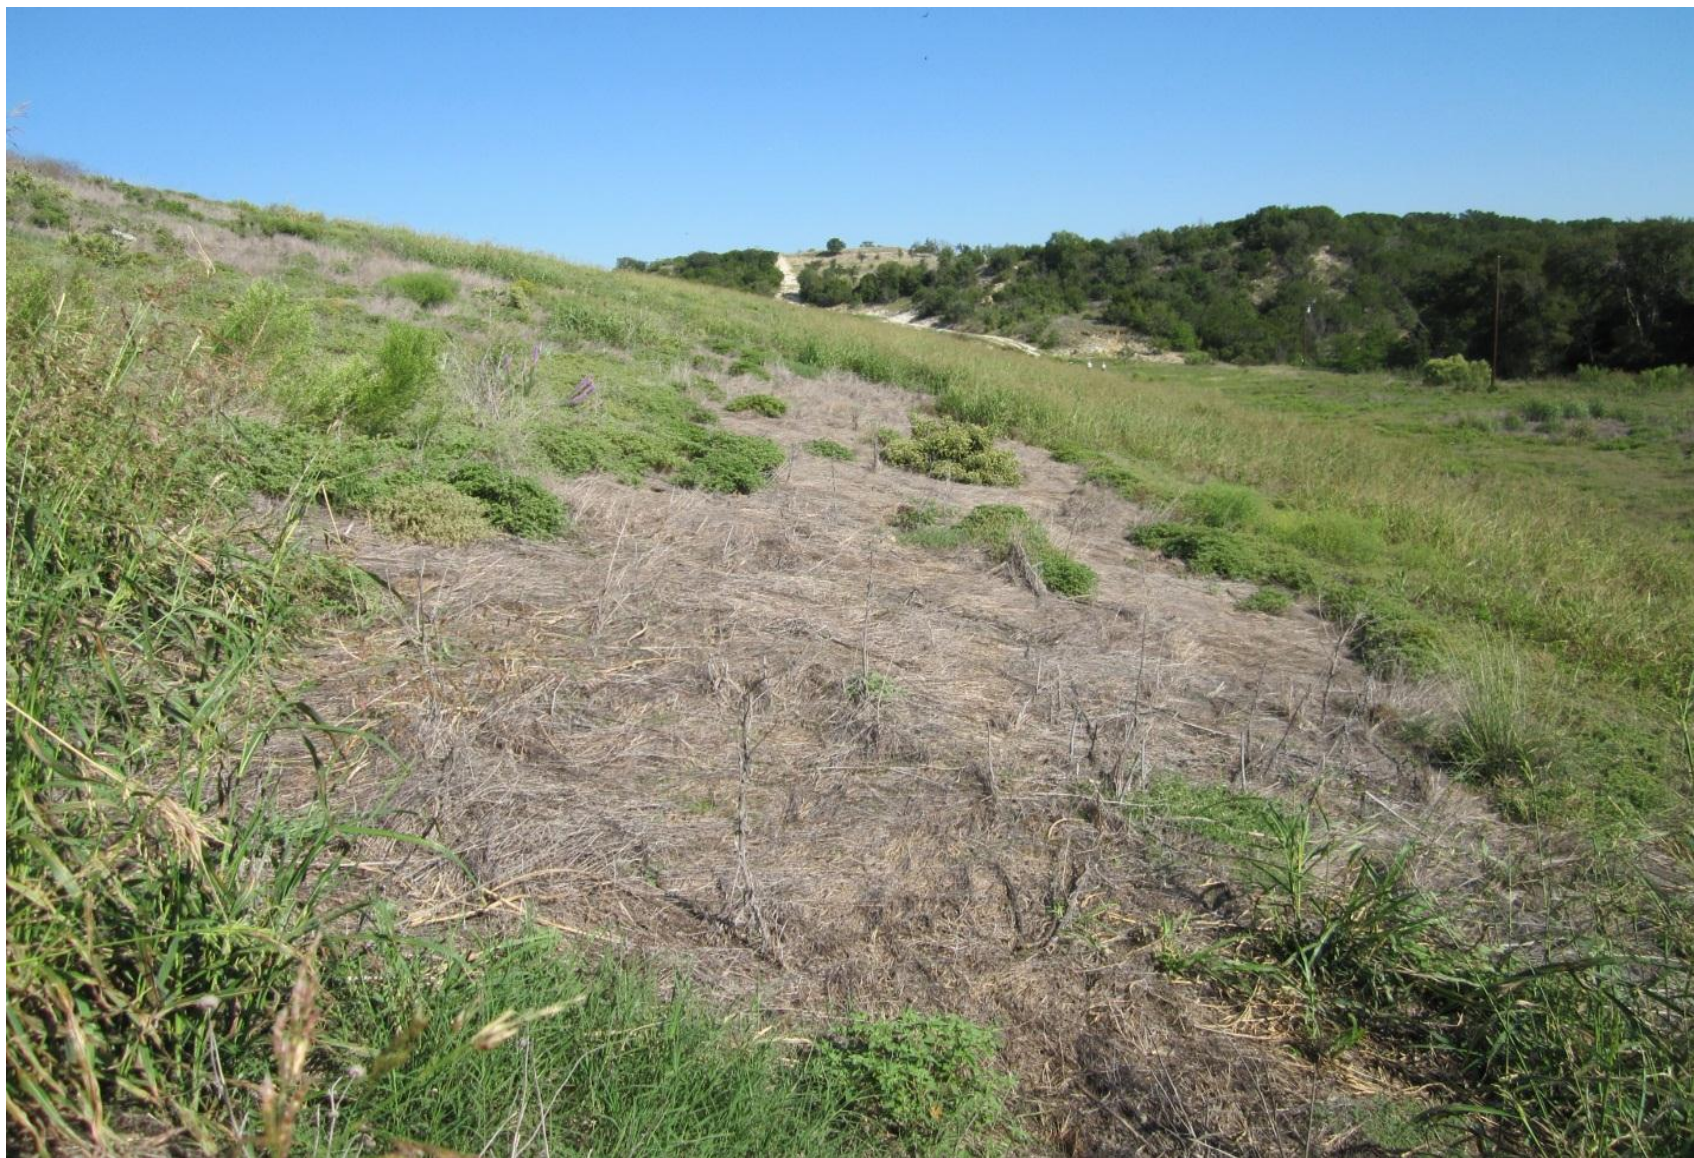
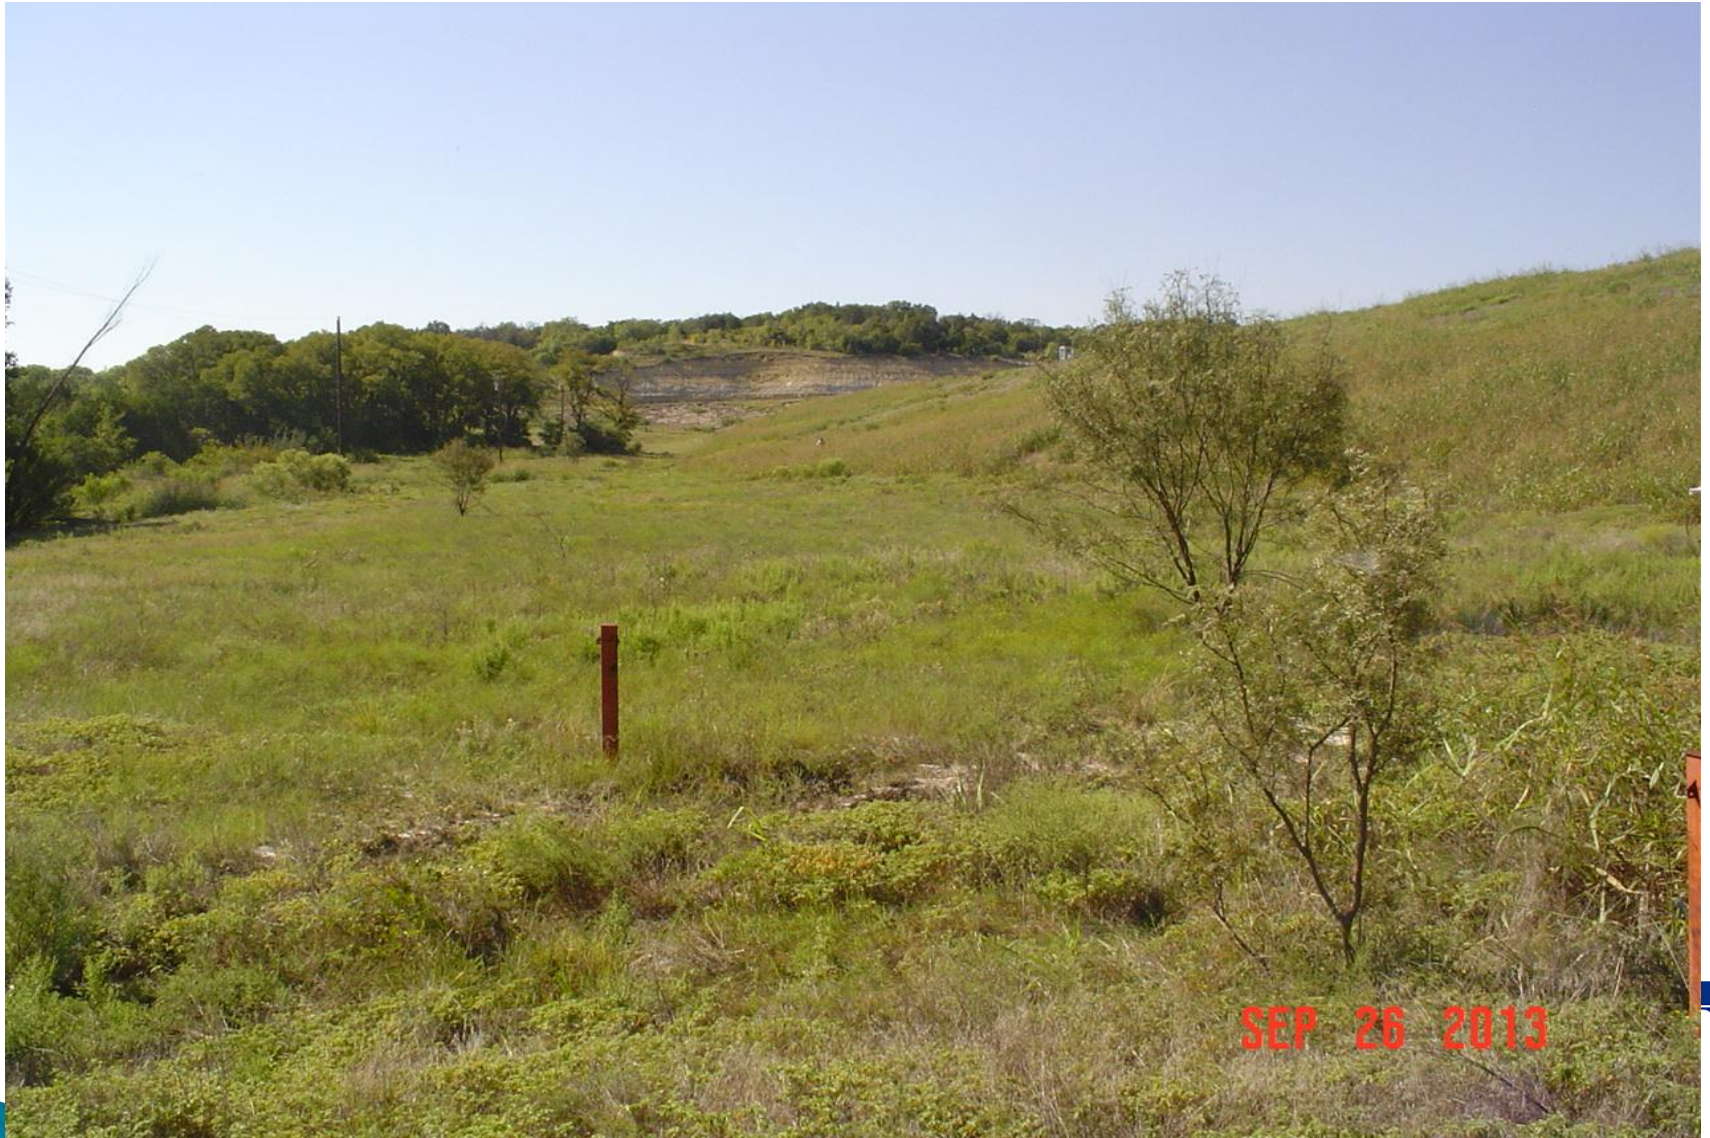
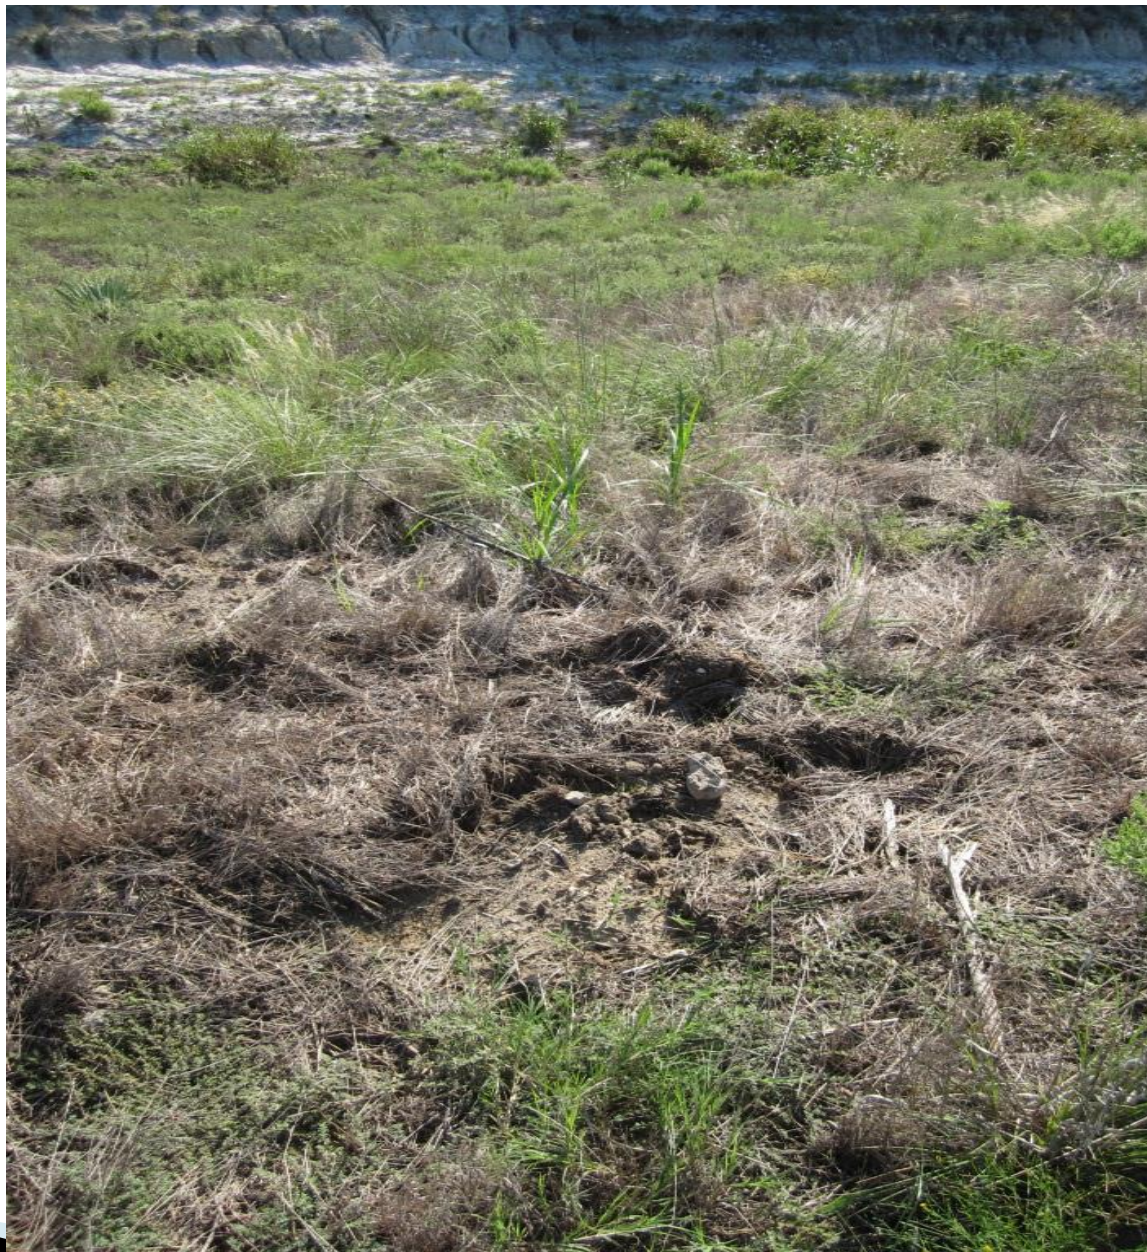
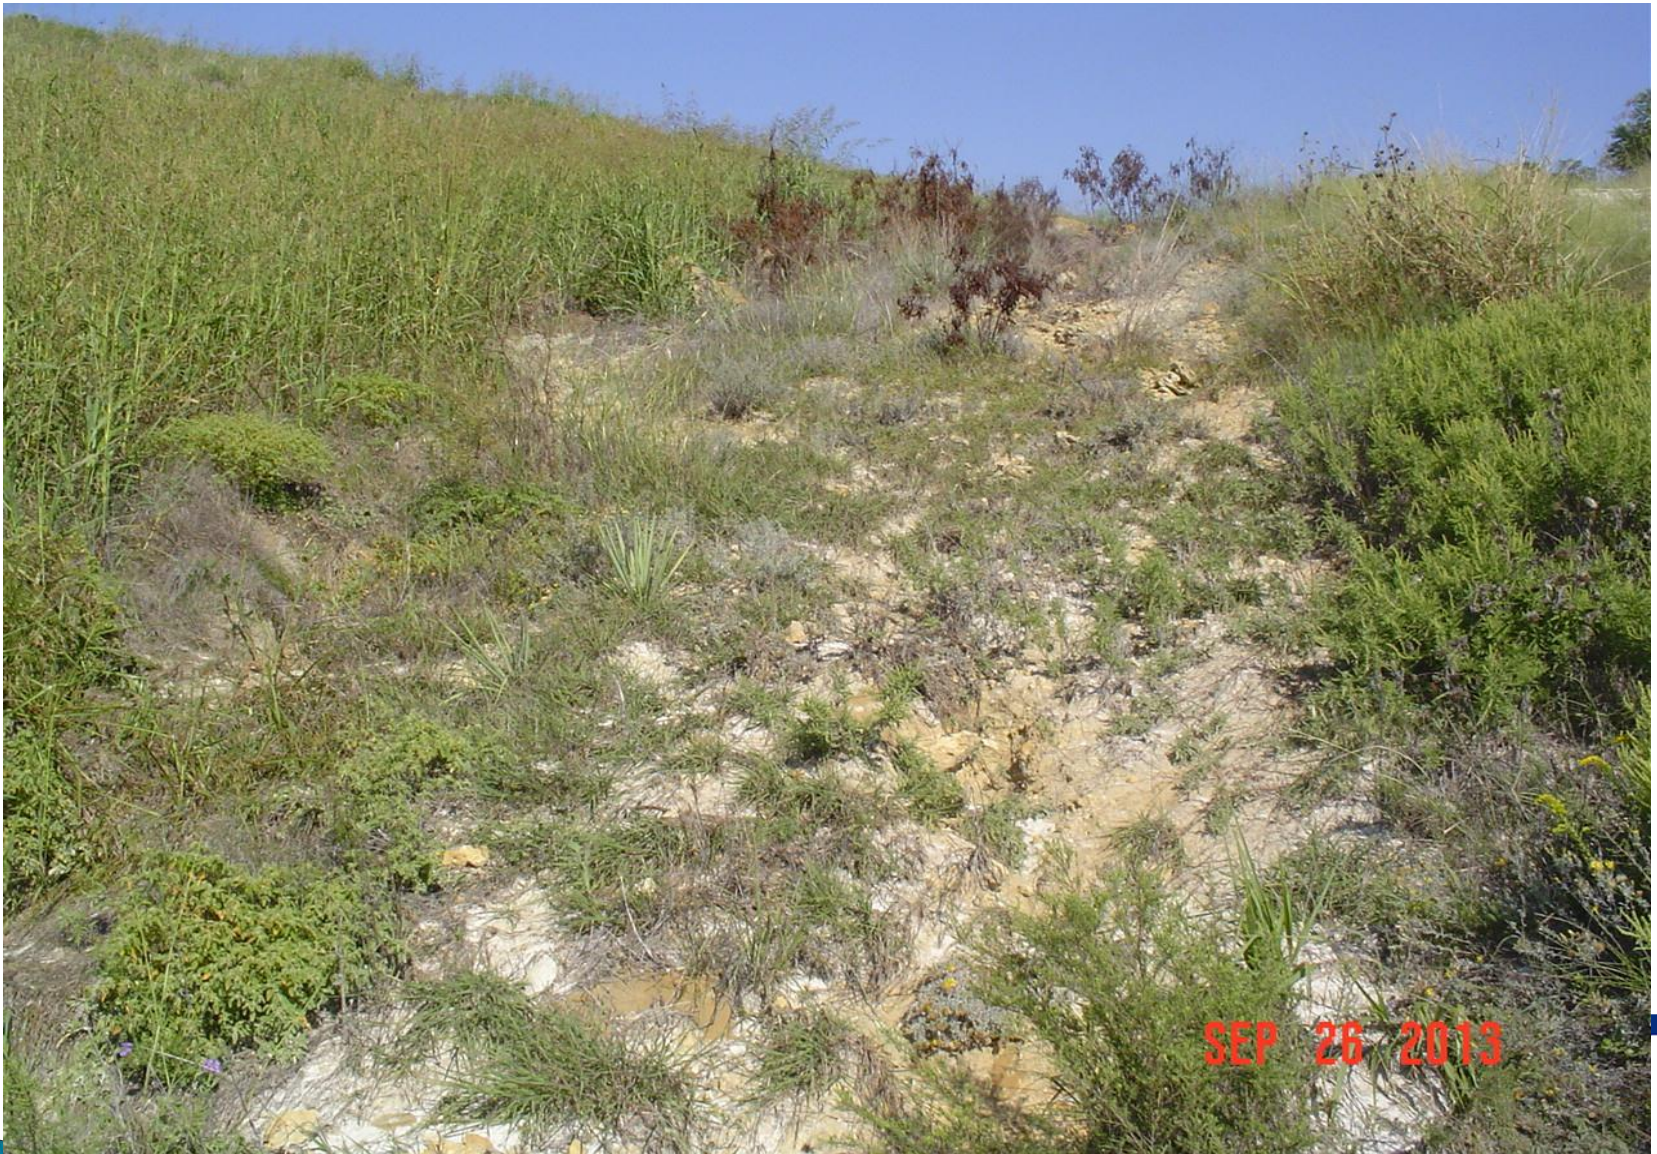
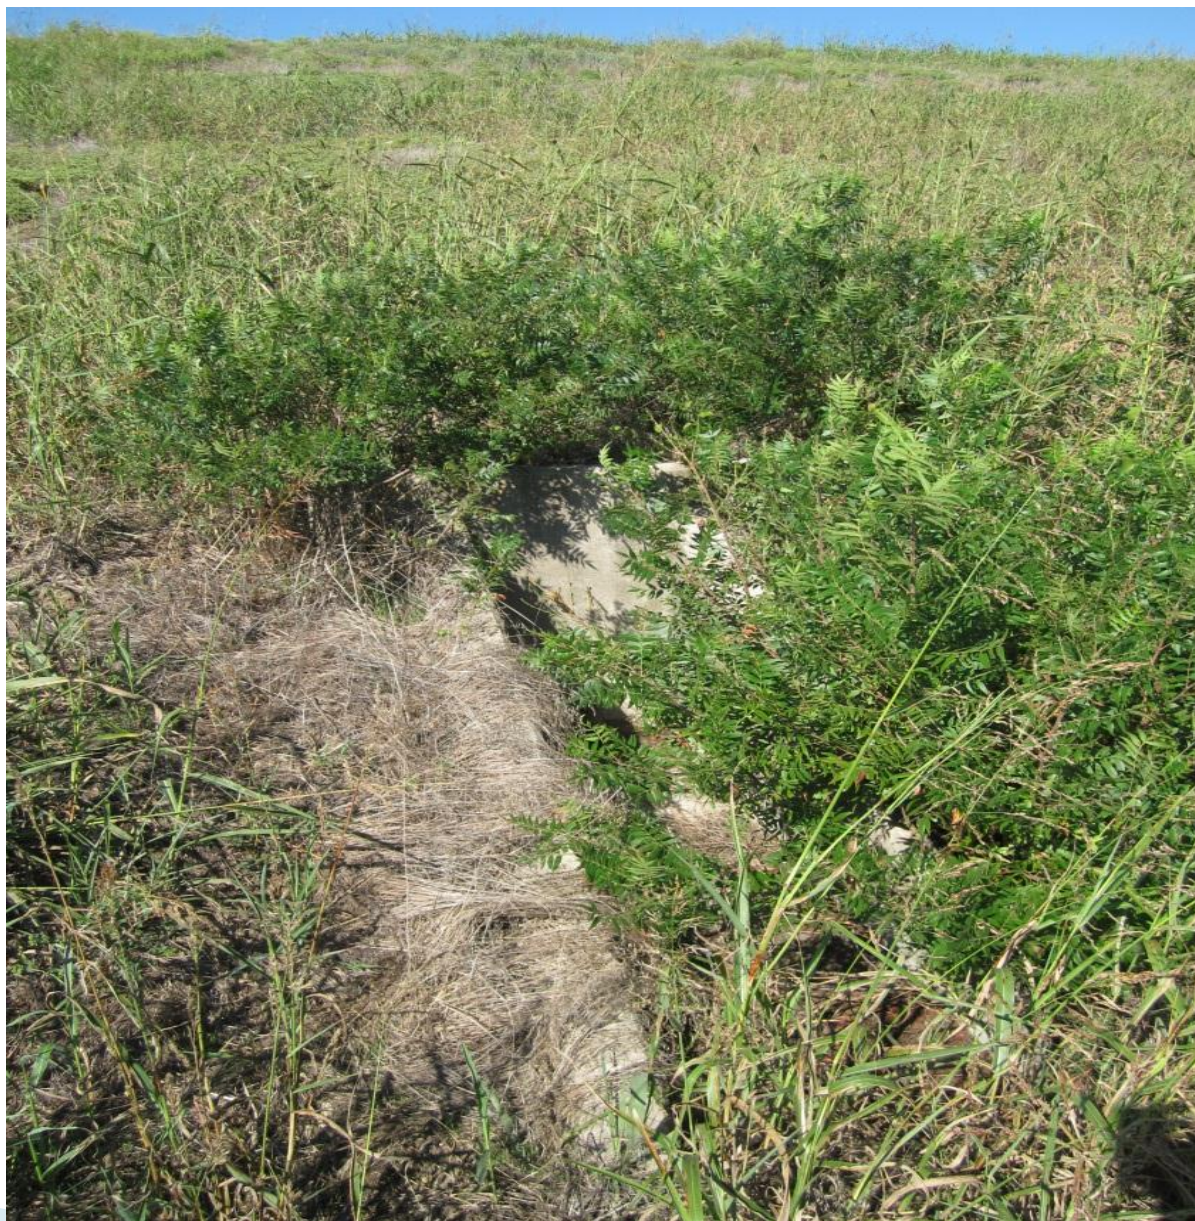
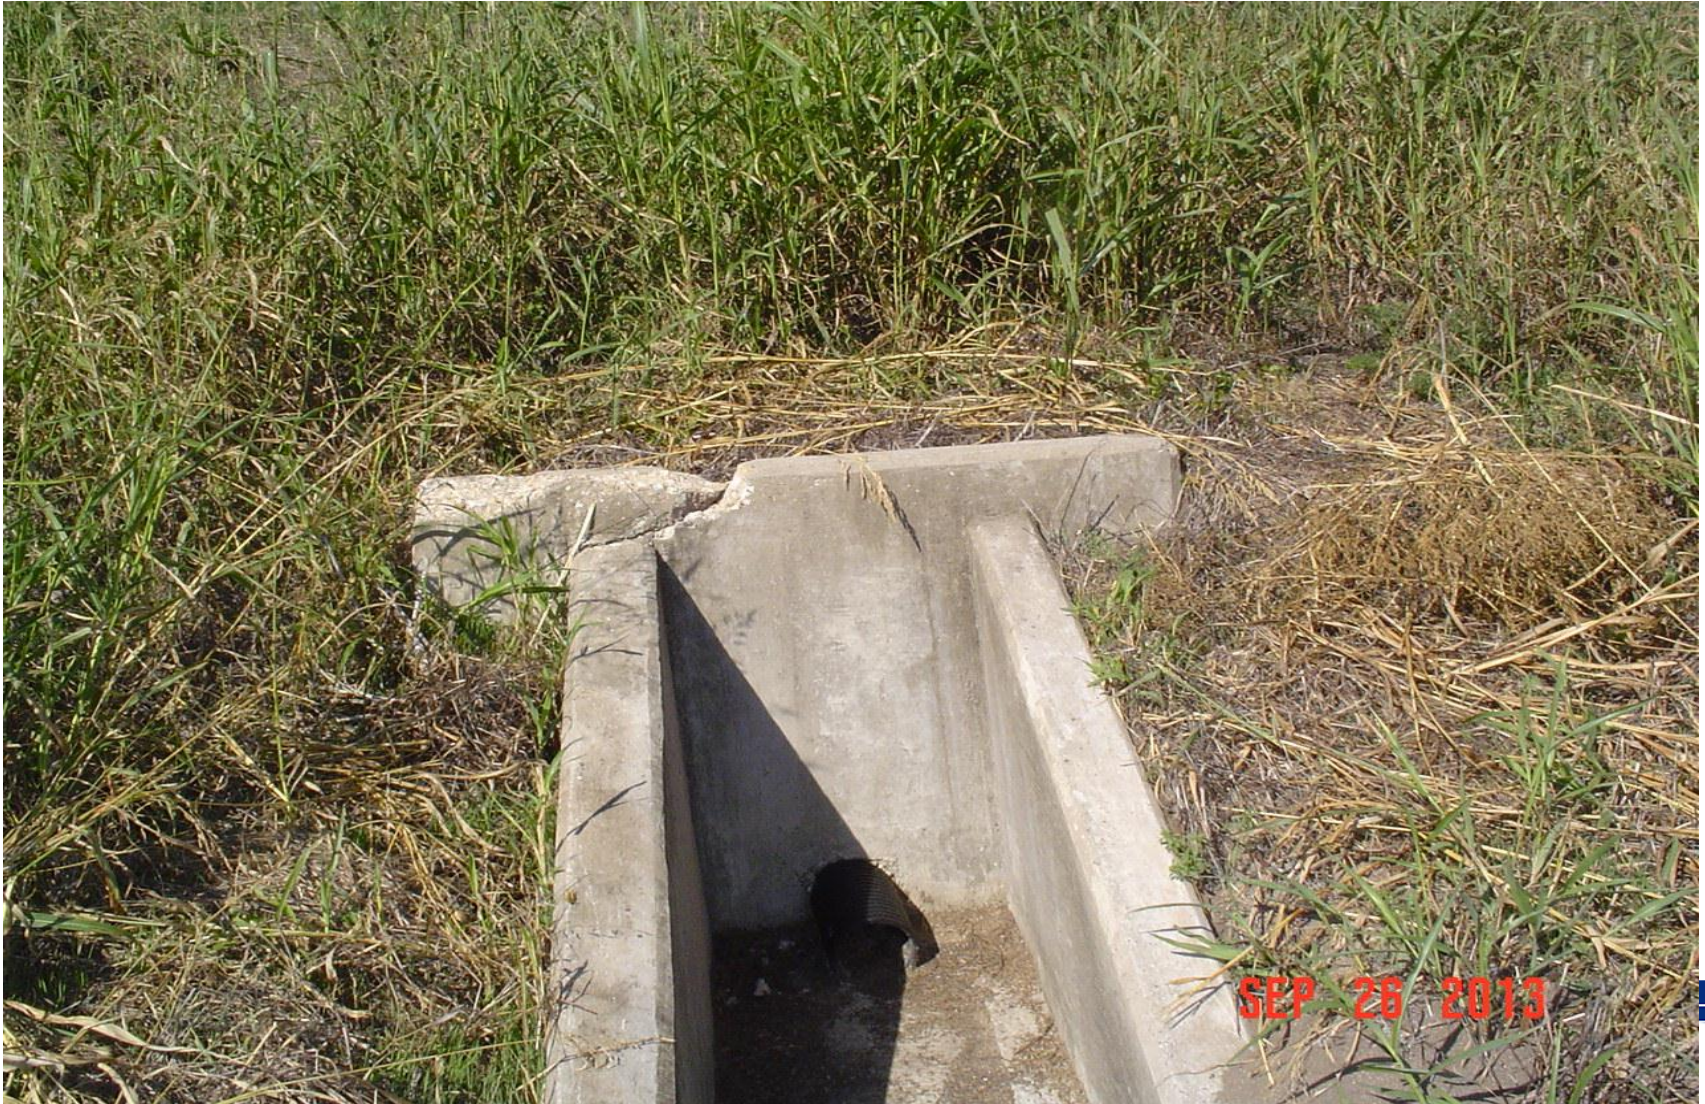
Downstream slope of the dam

- ▶ Lack of good grass cover
- ▶ Tall Johnson Grass on portions of the slope
- ▶ Hog damage
- ▶ Erosion at left groin
- ▶ Trees and vegetation around toe drain outlets
- ▶ Damaged toe drain outlet wall
- ▶ Piezometers (Readings taken?)

- ▶ The trees and other vegetation around the toe drain outlets should be removed. A periodic removal or spraying schedule should be established and followed.
- ▶ The pipes also need to be maintained clear. Periodic inspection of the outlets is recommended for any seepage flow.
- ▶ The downstream slope needed to be mowed and the grass cover needed to be reestablished.
- ▶ The hog damage on the slope should be monitored and repairs made as necessary.

- ▶ The erosion along the left groin of the dam should be monitored and repaired as necessary. Use of small dikes to divert the water flow from the hillside may be necessary.
- ▶ The toe drain outlet head wall that had been damaged needs to be repaired to prevent deterioration of the concrete due to exposure of the reinforcing steel. A method for marking the locations of the outlets was recommended to prevent mowers for hitting the walls.

- ▶ It was recommended that the piezometers along the downstream toe be investigated to determine if they are functional. If they are still functional, they should be periodically read and the readings evaluated (history of water loss from the reservoir).
